Devil's Slide/Hwy 1 Storm Repair

Daily Updates from Bijan Sartipi

Daily Update
June 20

Devil's Slide (post mile 39.14)

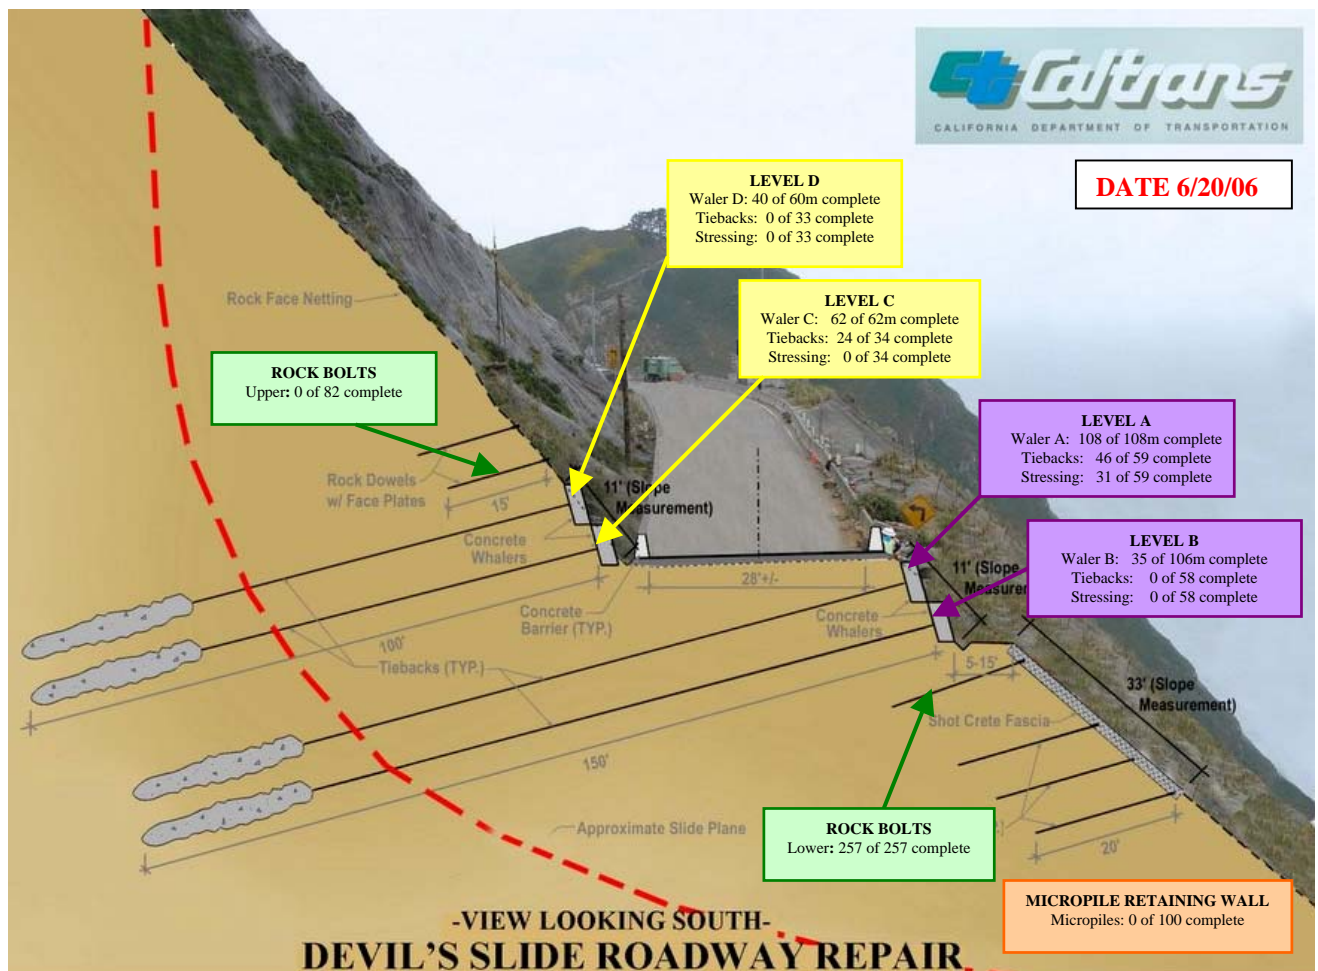
- Waler wall construction and tie back installation summary.

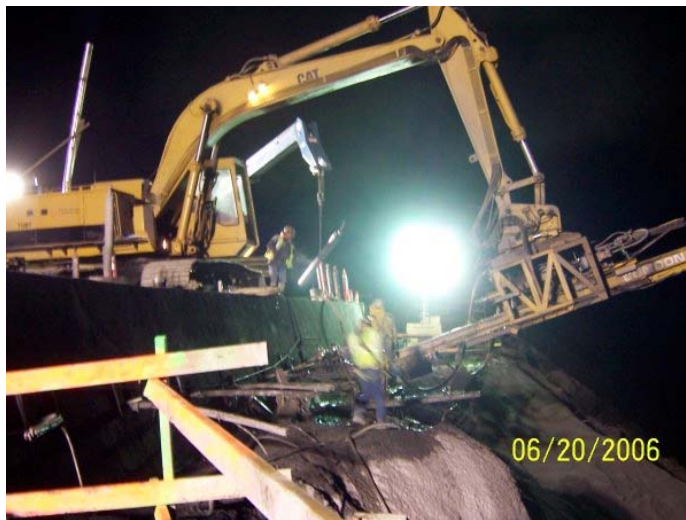
Drilling at level A

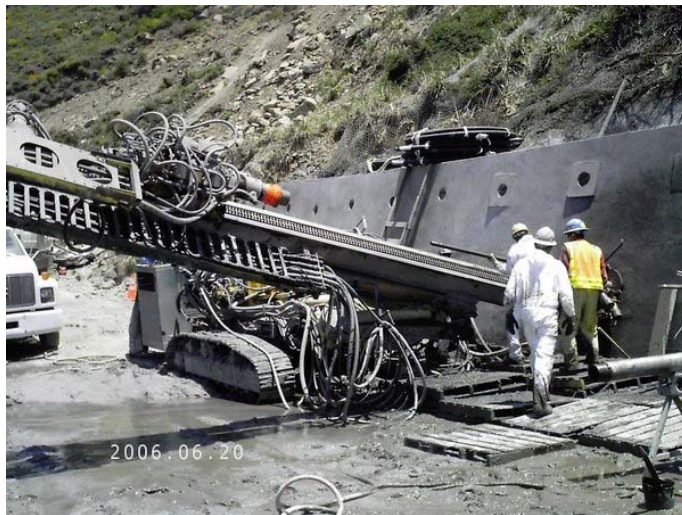
Drilling at level C

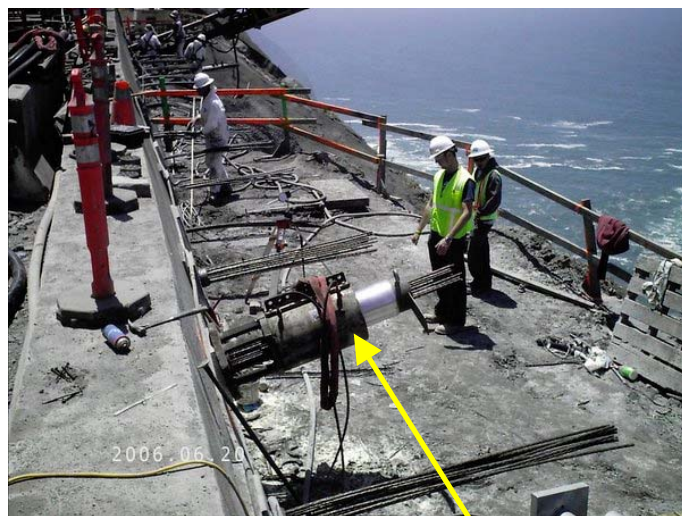
Stressing tie backs at level A using hydraulic ram

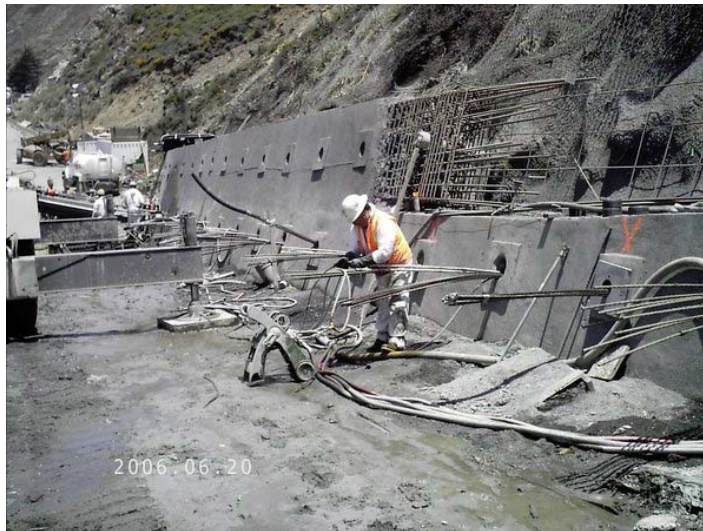
Injecting grout at level C to secure tie backs in place

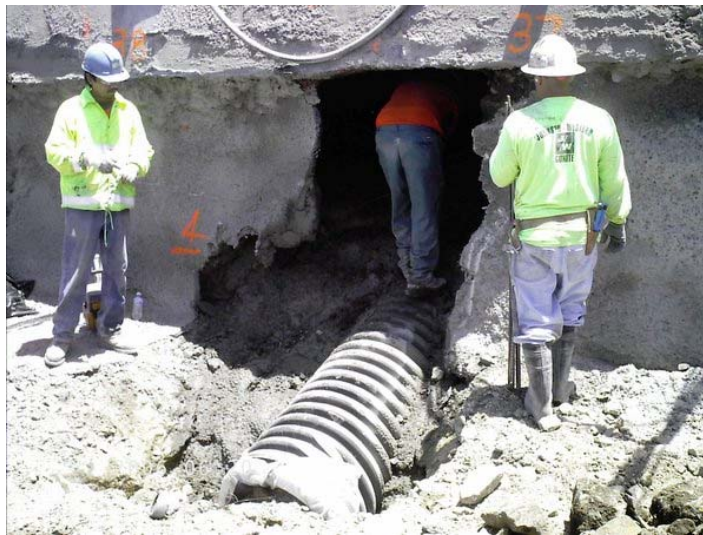
Preliminary drain work level B
